# VENTILATION ASSESSMENT REPORT

Mansfield Jordan Jackson Elementary School, MA

Report Date: Sept. 23, 2020

*RIS-87-20-0540 Ph 2*

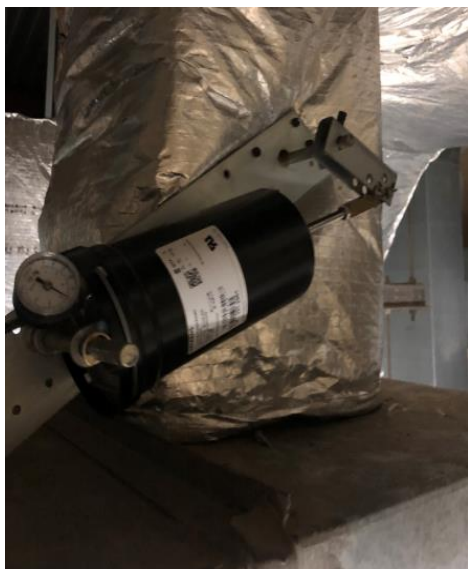
HV1 (Arts): In operation at the time of inspection. The OA damper was at a 0% open position, however actuator was showing the damper to be open. The unit had an older MERV 8 filter which should be replaced with a new MERV 13 filter.

Picture 1: HV1 OA Damper Actuator pressure gauge (15PSI)

*Re-inspection results: HV-1 was in operation and featured a recently replaced MERV 13 filter. The OA damper was open at 20% during the retest.*

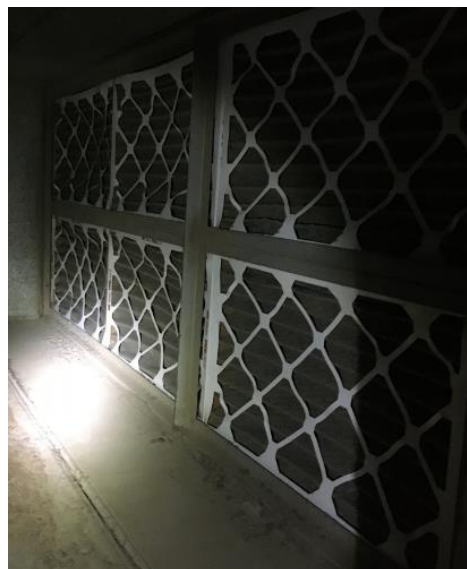
AC1: In operation at the time of inspection. The OA damper was at a 0% open position. The unit had an older MERV 8 filter which should be replaced with a new MERV 13 filter.

Picture 2: AC1 Dirty MERV 8 Filters

*Re-inspection results: AC-1 was in operation and featured a recently replaced MERV 13 filter. The OA damper was open at 20% during the retest.*

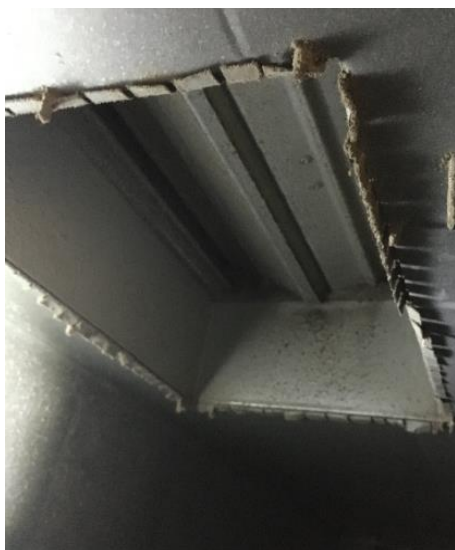
Picture 3: AC1 closed OA damper

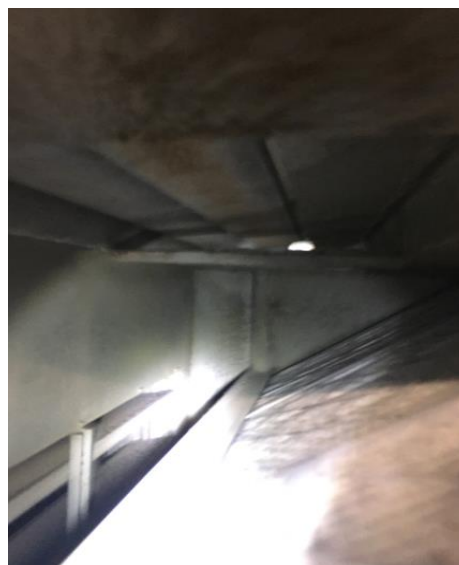
AC2 Cafe: In operation at the time of inspection. The OA damper was at a 10% open position, damper linkage appears to be broken or needs adjustment. The unit had an older MERV 8 filter which should be replaced with a new MERV 13 filter.

Picture 4: AC2 partially open OA damper

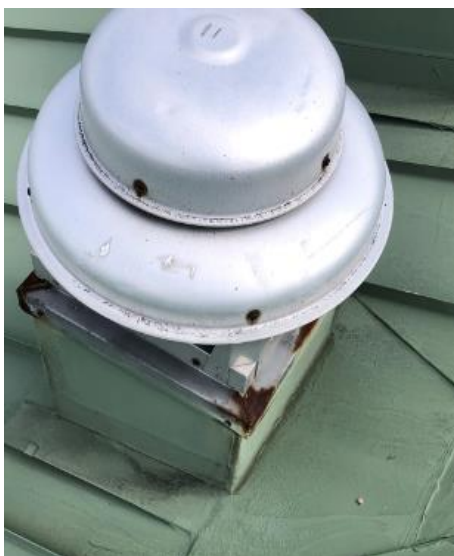
Picture 5: EF11 on the roof

RISE observed 34 EF's on the roof, of which 82% were not in operation. RISE understand that the school was working to addressing the EF controls during the visit.

It is imperative to identify, troubleshoot, and repair/replace all non-operational EF which serves occupied spaces. It is also suggested that all exhaust fans be verified to have the proper size (length and width) belt, and that all are fully functional. The second course of action would be to look for and correct any poor duct work transitions which create excessive pressure drop for the fan motors to overcome.

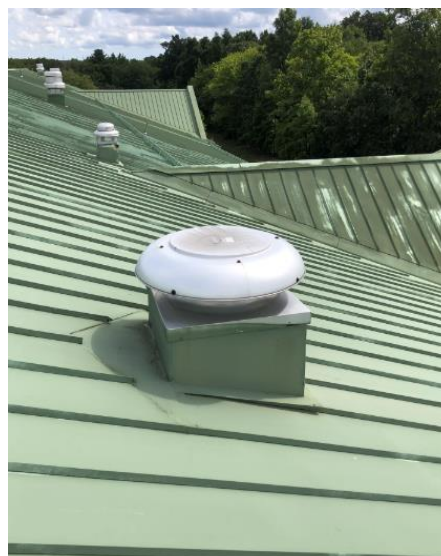
*Re-inspection results: RISE observed 6 EF's on the roof that were not operational. The percentage of non-operational fans dropped to 17.6%.*

Picture 5: Multiple inspected EFs on the roof

*Re-inspection results: RISE recommends repairing the remaining 6 EF's. If the fan is controlled via a switch, the switch should be left on when the school is occupied.*

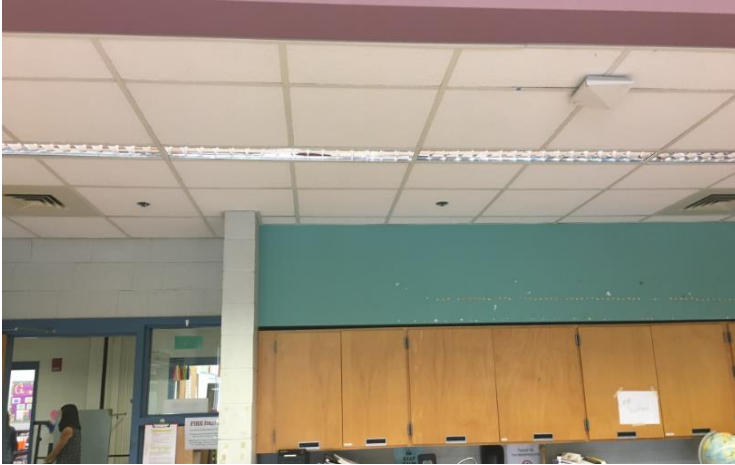
Picture 7: Typical exhaust setup with transfer grill left and exhaust grill right

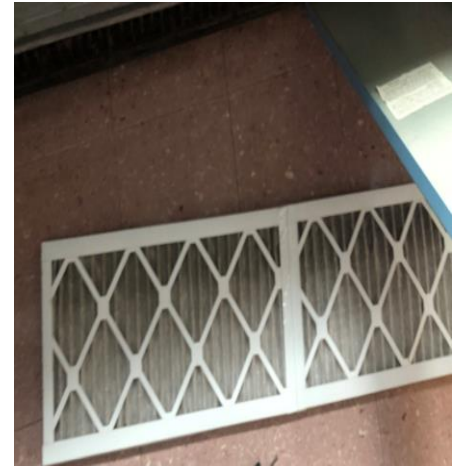
Picture 10: Dirty UV filter B118

All classrooms inspected had a means of supplying OA through the existing UV's. It is recommended to check all UV's at the facility to ensure proper operation, set UV fan speed to high, change filters, ensure OA damper responds to commands from pneumatic controls, and command OA damper to follow table 4 OA based on each UV type. Each location UV type can be identified from the building mechanical plans. This will also provide an opportunity to make any necessary repairs to each UV at the facility. Of note, 16% of filters inspected were more than 6 months old. 50% of UV's inspected had OA damper - 90-100% open, the remainder were 100% closed. Changing the filters to MERV13, if possible can have more significant impact on the quality of air in the room given that it is around 90% efficient at filtering particle sizes between 0.3-1Nm, whereas MERV8 filters are only 20% efficient for removal of particulates the size of viruses and bacteria.

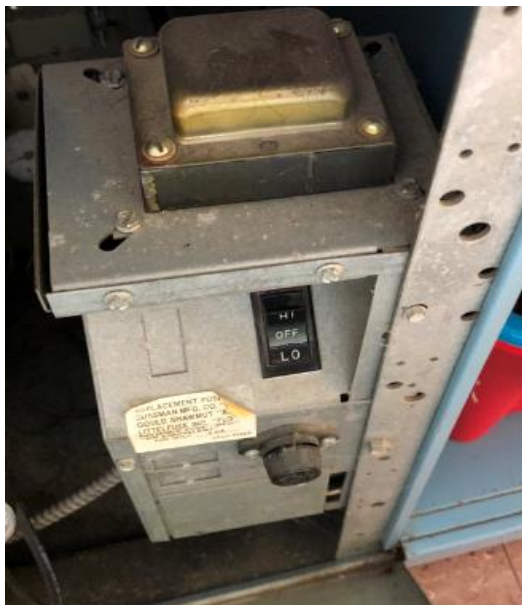
Picture 11: UV Fan speed on low setting

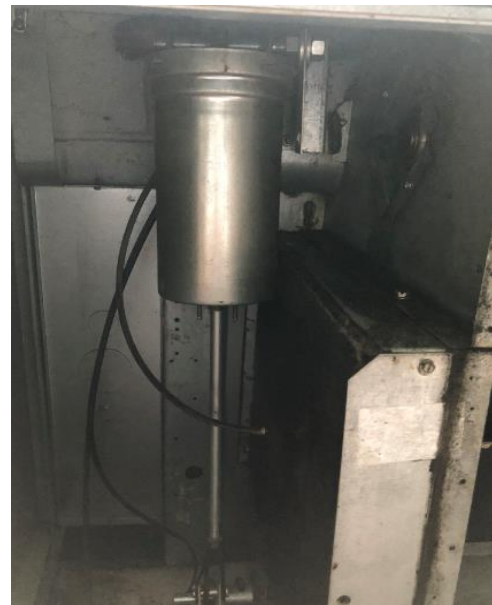
Room #	UV Fan Speed	UV OA Damper % Open	Replace Filter (y/n)	Exhaust Present (y/n)	Additional Comments
B112	Low	90%	n	y	
B119	Low	90%	n	y	
B223	Low	0%	n	y	
B221	Low	0%	n	y (Transfer Grill)	OA damper actuator Disconnected
A128	Low	0%	y	y	
A123	Low	100%	n	y	OA damper actuator Disconnected

Picture 12: Disconnected OA Damper actuator Rm 221
