# VENTILATION ASSESSMENT REPORT

Mansfield Qualters Middle School

This report summarizes the findings from a walk-through completed at the Qualters Middle School in Mansfield, MA, by RISE Engineering.

Report Date: Sept. 29, 2020

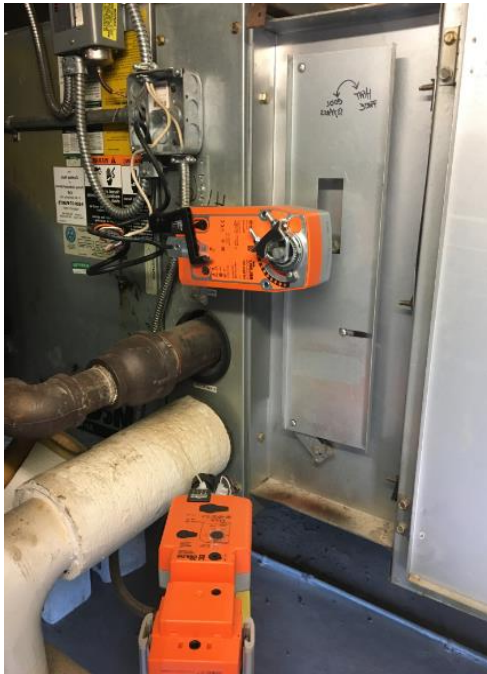
HV 6 (Girls Locker Room): Contractor working on this unit at time of inspection, installing new controls, not in operation. The OA damper was at a 100% open position. The unit has an older MERV 8 filter which will be getting replaced with a new MERV 13 filter.

Picture 1: New Controls HV 6

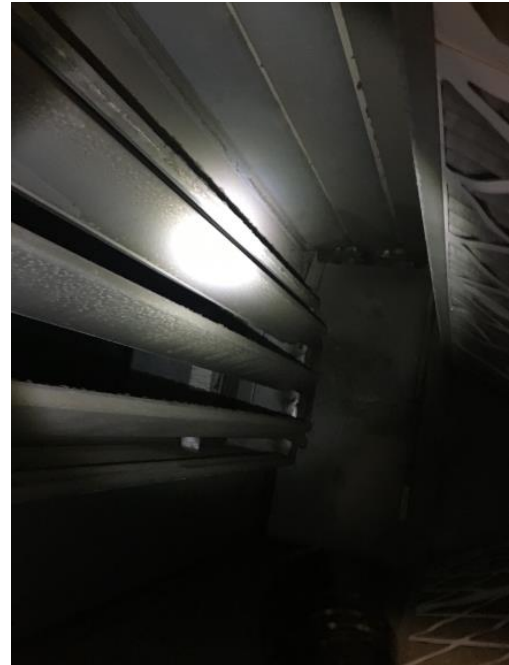
HV 2 (Auditorium): In operation at time of inspection. The OA damper was at a 100% open position. The unit has an older MERV 8 filter which will be getting replaced with a new MERV 13 filter. Controls in process of being updated.

*Re-inspection results: HV-2 was in operation and featured a recently upgraded MERV 13 filter.*

Picture 2: HV2 OA Damper open

*Re-inspection results: All retested equipment were found to be in working order, however the outside air (OA) dampers physical position on AHU-1 and HV-2 were found to be closed. It is recommended to check if the actual position match the EMS position and review the actuator operation. RISE recommends setting the OA dampers to the recommended position for each unit.*

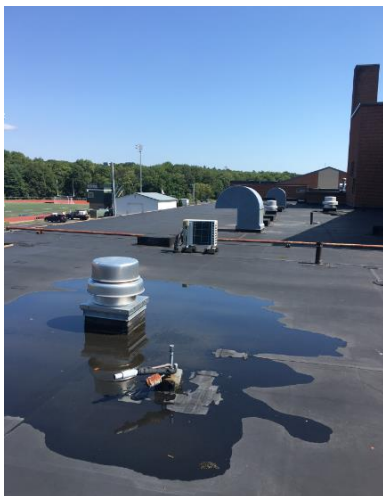
At the initial site visit, RISE observed 30 EF's on the roof, of which 77% were not in operation. The Mansfield Facilities Department informed RISE at the time of the inspection that they were actively working to restore all EF's to operable condition.

*Re-inspection results: RISE observed 7 EF's on the roof that were non-operational. The percentage of non-operational fans dropped to 21%. RISE understands that facilities have been working to rectify the non-operational equipment.*

Picture 3: Inoperable EF

*Re-inspection results: RISE recommends repairing the remaining 7 EF's. If the fan is controlled via a switch, the switch should be left on when the school is occupied.*

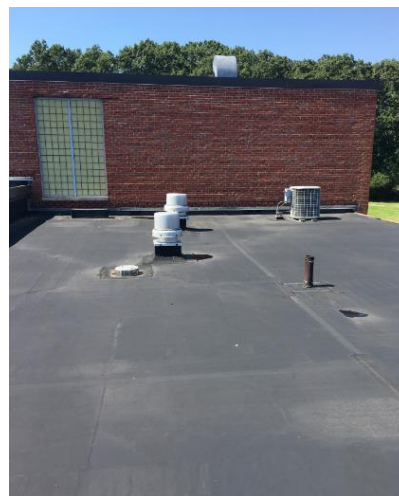
Picture 4: Inoperable EF's, no power

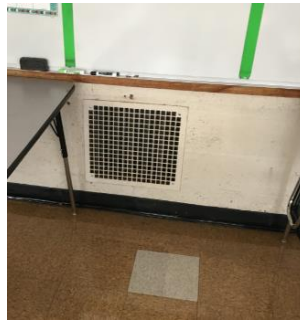
Picture 6: Typical Exhaust

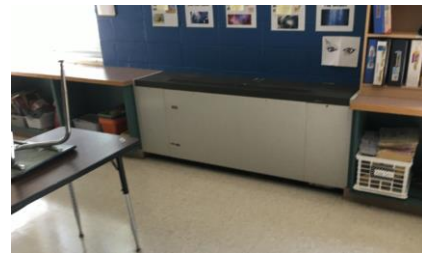
Picture 7: Typical Classroom UV

All classrooms inspected had a means of supplying OA through the existing UV's. It is recommended to check all UV's at the facility to ensure proper operation, set UV fan speed to high, replace filters as needed and ideally upgrade to MERV 13 if they fit the equipment, set OA minimum damper position to 10%,

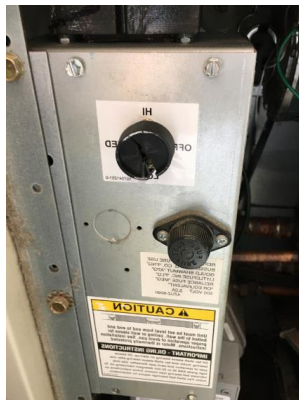
Picture 8: Broken Fan Control Rm 106

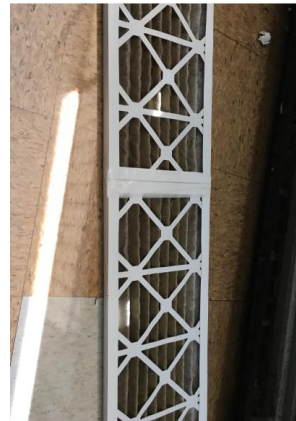
Picture 9: Filter requiring replacement Rm 108

flowrate needed. It is also suggested to perform an interior cleaning of each UV while they are open for inspection, maintenance. Of note, 45% of filters inspected were more than 6 months old. Cleaning the inside of the UV cabinets will help prolong UV filter life. At the initial inspection, it was observed that 45% of UV's inspected had OA damper 0% open, the remainder were approximately 10% open.

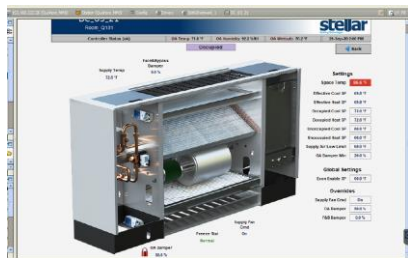
Picture 10: Rm 131 Updated OA Damper Position

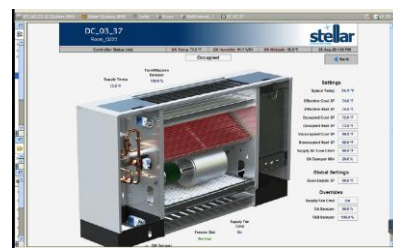
Picture 11: Rm 223 Updated OA Damper Position

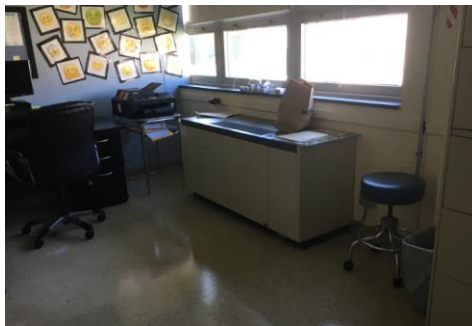
Nurse Room is served by a unit ventilator w/ OA and a dedicated exhaust system. The UV is controlled by a dedicated thermostat. There is a steam radiator present which is not in operation, as well as a mini-split AC unit, and operable windows in the Main Nurse Office. There are supply duct registers present, but these are disconnected from the HVAC system and abandoned in place. The nursing area is broken up into 8 smaller rooms:

Heat and OA is supplied to these rooms by the UV. Each of these rooms has its own exhaust outlet(s), however the EF servicing this area was not in operation at the time of the inspection. This was confirmed visually when inspecting the EF's on the rooftop, the EF located above the Nursing Area was not running. It is recommended to add a means of supplying conditioned outside air directly to the Isolation Room, as this room only has exhaust present.

Picture 10: Nursing Area UV

The Exhaust Fan which serves this area was noted as not being in operation at the time of the inspection. It is imperative to remedy this issue. **As of the writing of this report, it has been noted that**

**this EF has been restored to operation.** The recommended total turnover air rate for the Nurse's area is between 4 to 6 air changes per hour with a minimum of 2 air changes per hour representing fresh outside air. It is also suggested to add a means of supplying conditioned outside air directly to the isolation room to ensure comfort of patients. The nurse room should always operate under negative pressure to eliminate the risk of contaminated air leaving the space.
