VENTILATION ASSESSMENT REPORT

Mansfield Jordan Jackson Elementary School, MA

Abstract

Report Date: Sept. 23, 2020

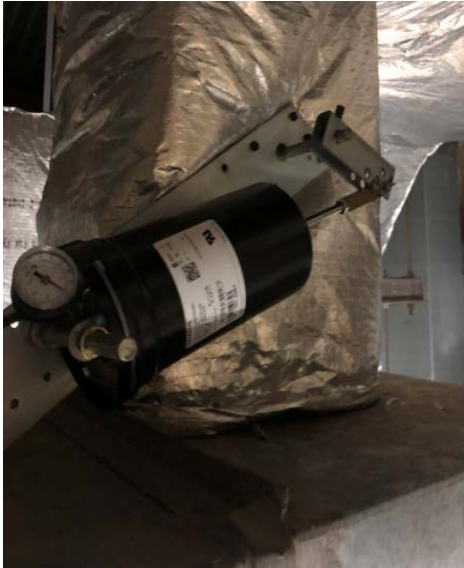
HV1 (Arts): In operation at the time of inspection. The OA damper was at a 0% open position, however actuator was showing the damper to be open. The unit had an older MERV 8 filter which should be replaced with a new MERV 13 filter.

Picture 1: HV1 OA Damper Actuator pressure gauge (15PSI)

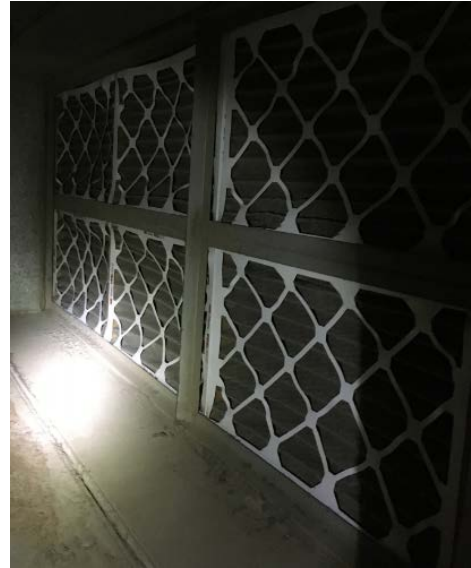
AC1: In operation at the time of inspection. The OA damper was at a 0% open position. The unit had an older MERV 8 filter which should be replaced with a new MERV 13 filter.

Picture 2: AC1 Dirty MERV 8 Filters

The HVAC equipment inspected was generally found to be in good condition. It is recommended to upgrade all of the units to new MERV 13 filters as well as confirm that OA dampers on each piece of HVAC equipment respond to commands from pneumatic control system. It is recommended that all units supply fan run at 100% continuous speed while the building is occupied. The units' minimum

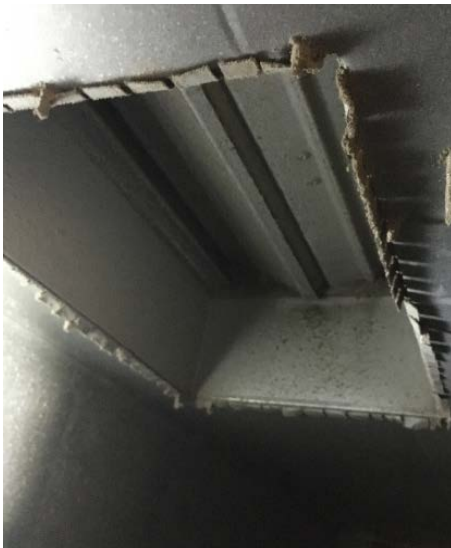
Picture 3: AC1 closed OA damper

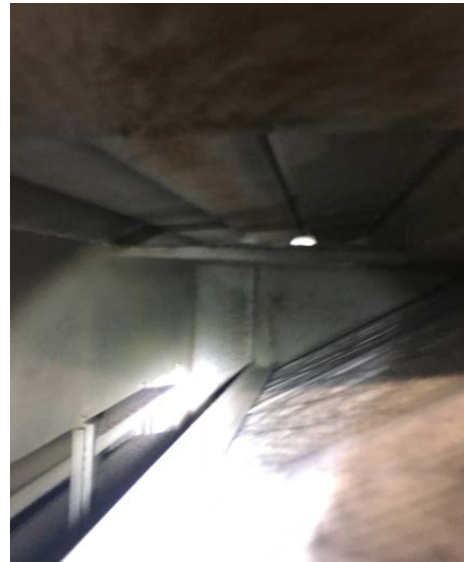
AC2 Cafe: In operation at the time of inspection. The OA damper was at a 10% open position, damper linkage appears to be broken or needs adjustment. The unit had an older MERV 8 filter which should be replaced with a new MERV 13 filter.

Picture 4: AC2 partially open OA damper

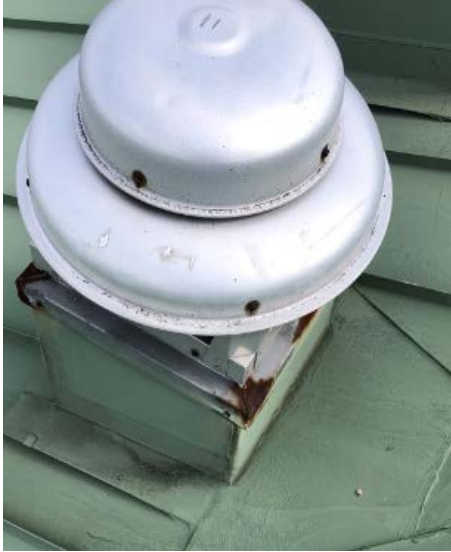
RISE observed 34 EF's on the roof, of which 82% were not in operation. RISE understand that the school was working to addressing the EF controls during the visit.

Picture 5: EF11 on the roof

It is imperative to identify, troubleshoot, and repair/replace all non-operational EF which serves occupied spaces. It is also suggested that all exhaust fans be verified to have the proper size (length and width) belt, and that all are fully functional. The second course of action would be to look for and correct any poor duct work transitions which create excessive pressure drop for the fan motors to overcome.

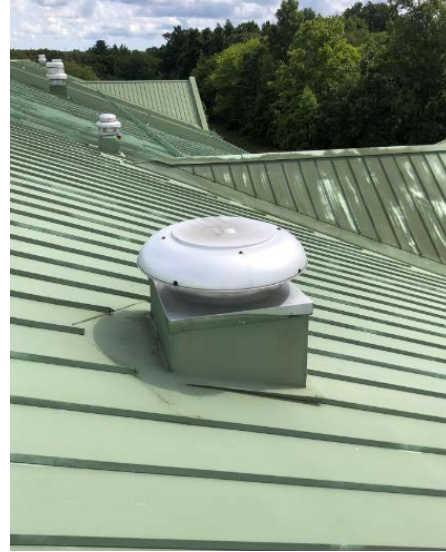
Picture 5 : Multiple inspected EFs on the roof

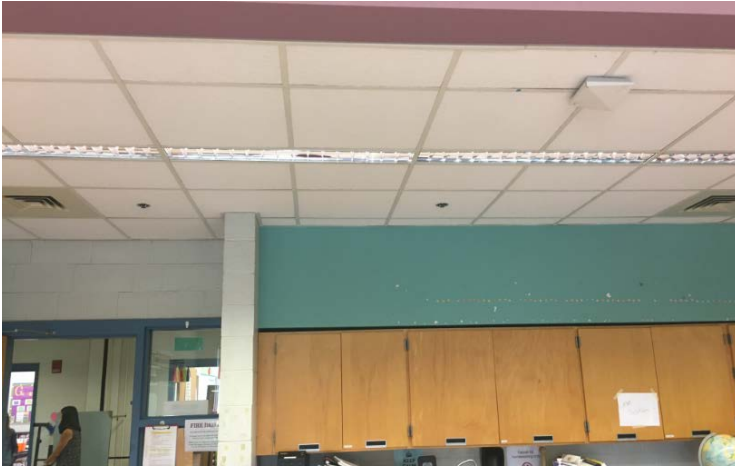
Classrooms served by UV's were found to have a generally accepted supply and exhaust distribution with UV SA/OA diffuser on the window side of the class, and one exhaust vent on the door side of the room. There are several classrooms noted in the above table which do not have exhaust present, or the cabinet mounted exhaust fan was not in operation at time of inspection, which needs to be addressed.

Picture 7: Typical exhaust setup with transfer grill left and exhaust grill right

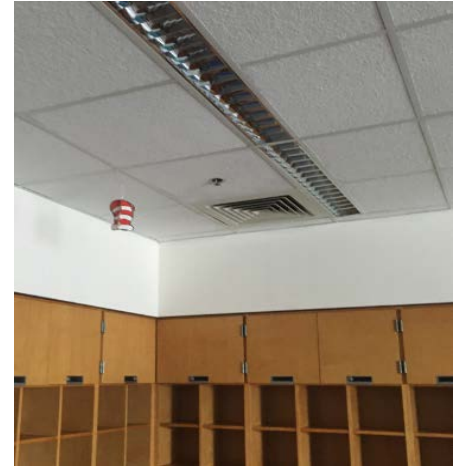
Picture 8: Classroom exhaust grill

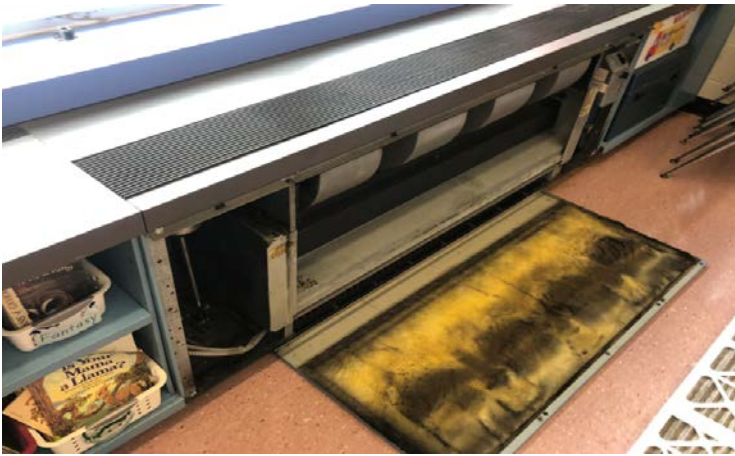
Picture 9: Typical Classroom UV

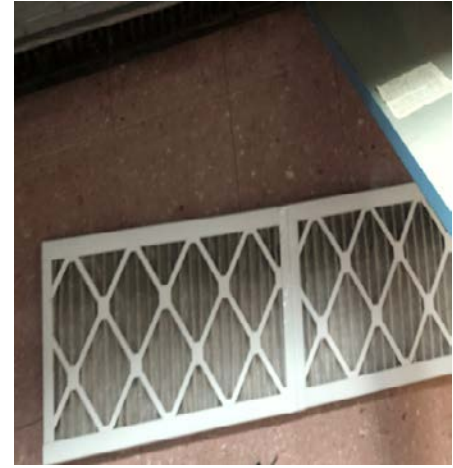
Picture 10: Dirty UV filter B118

All classrooms inspected had a means of supplying OA through the existing UV's. It is recommended to check all UV's at the facility to ensure proper operation, set UV fan speed to high, change filters, ensure OA damper responds to commands from pneumatic controls, and command OA damper to follow table 2 OA based on each UV type. Each location UV type can be identified from the building mechanical plans. This will also provide an opportunity to make any necessary repairs to each UV at the facility. Of note, 16% of filters inspected were more than 6 months old. 50% of UV's inspected had OA damper - 90-100% open, the remainder were 100% closed. Changing the filters to MERV13, if possible can have more significant impact on the quality of air in the room given that it is around 90% efficient at filtering particle sizes between 0.3-1Nm, whereas MERV8 filters are only 20% efficient for removal of particulates the size of viruses and bacteria.

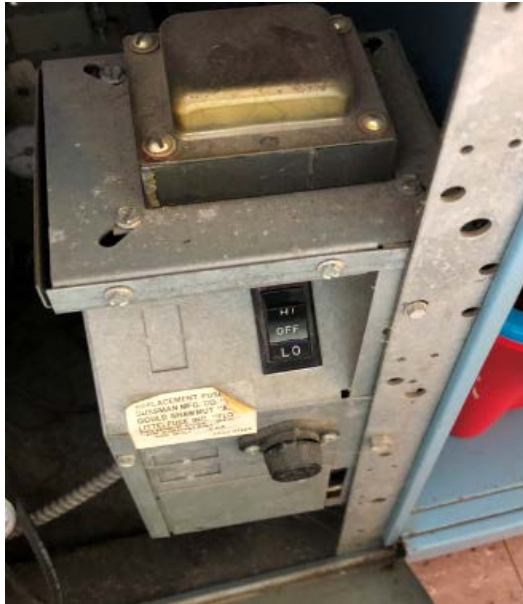
Picture 11: UV Fan speed on low setting

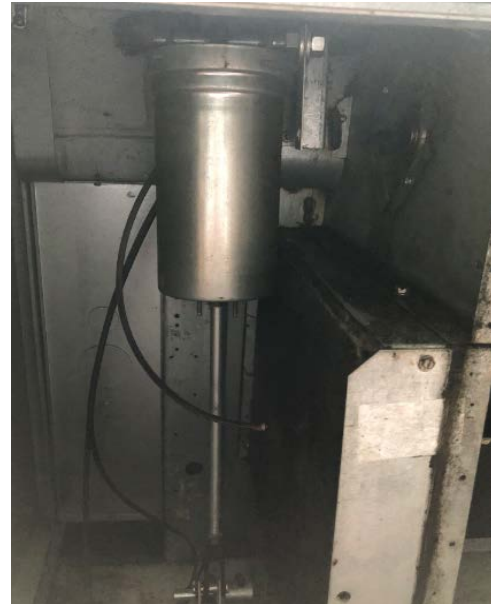
Room #	UV Fan Speed	UV OA Damper % Open	Replace Filter (y/n)	Exhaust Present (y/n)	Additional Comments
B112	Low	90%	n	y	
B119	Low	90%	n	y	
B223	Low	0%	n	y	
B221	Low	0%	n	y (Transfer Grill)	OA damper actuator Disconnected
A128	Low	0%	y	y	
A123	Low	100%	n	y	OA damper actuator Disconnected

Picture 12: Disconnected OA Damper actuator Rm 221

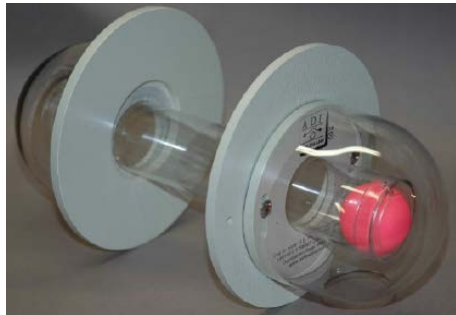
The picture to the left shows an easily visible means to determine the pressure status of an isolation patient room. The device is mounted in the partition wall of the room to the corridor. The ball moves as the pressure moves from negative to positive (such as the door is opened and closed or an HVAC equipment malfunction) to remind those in care of the sick to maintain a negative pressure in the room so the patient's breathing is contained within the room's exhaust system instead of being transferred to an adjacent area.
