VENTILATION ASSESSMENT REPORT

Mansfield Qualters Middle School

This report summarizes the findings from a walk-through completed at the Qualters Middle School in Mansfield, MA, by RISE Engineering.

Report Date: Sept. 29, 2020

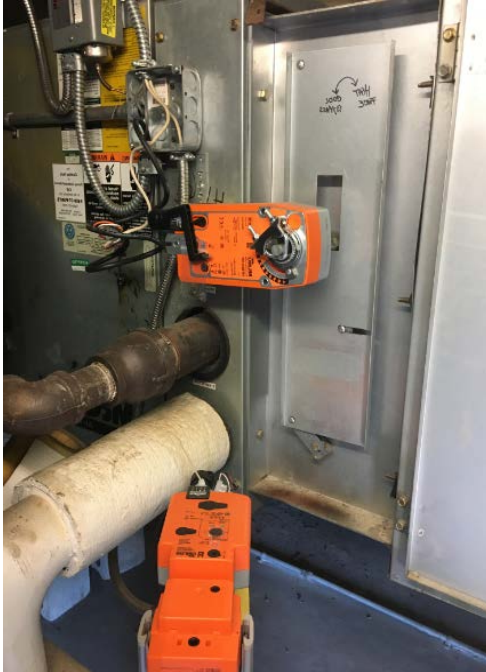
HV 6 (Girls Locker Room): Contractor working on this unit at time of inspection, installing new controls, not in operation. The OA damper was at a 100% open position. The unit has an older MERV 8 filter which will be getting replaced with a new MERV 13 filter.

Picture 1: New Controls HV 6

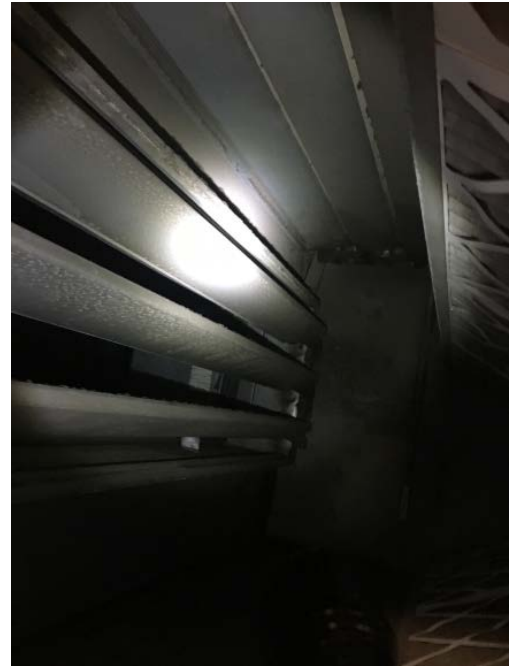
HV 2 (Auditorium): In operation at time of inspection. The OA damper was at a 100% open position. The unit has an older MERV 8 filter which will be getting replaced with a new MERV 13 filter. Controls in process of being updated.

Picture 2: HV2 OA Damper open

The HVAC equipment inspected was generally found to be in good condition. It is recommended to upgrade all of the units to new MERV 13 filters as well as confirm that OA dampers on each piece of HVAC equipment respond to commands from the new EMS system which is currently being installed. The units' minimum outside air damper were found to vary from 0% to 10%. It is recommended that all units supply fan run at 100% continuous speed while the building is occupied. The OA dampers on each piece of HVAC equipment should be set to at least 50% minimum position during occupied hours based on original OA design. Demand control ventilation CO2 set point should be set to 750PPM on all HVAC units. **As of the writing of this report, it has been confirmed that the OA dampers for the HV systems have been commanded to the 50% open position during occupied hours in the new BMS system.**

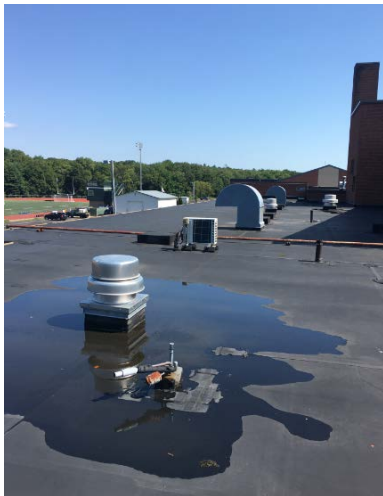
At the initial site visit, RISE observed 30 EF's on the roof, of which 77% were not in operation. The Mansfield Facilities Department informed RISE at the time of the inspection that they were actively working to restore all EF's to operable condition.

Picture 3: Inoperable EF

It is imperative to ensure that the EF's servicing the Nurse's Room and Classrooms are operational. It is also suggested that all exhaust fans be verified to have the proper size (length and width) belt, and that all are fully functional. The second course of action would be to look for and correct any poor duct work transitions which create excessive pressure drop for the fan motors to overcome. It was also noted that the restrooms had exhaust inlets, but the EF's servicing them were not in operation. The below pictures show examples of the roof mounted fans. **As of the writing of this report, all but 2 EF's (95% of total) have been restored to full operation.**

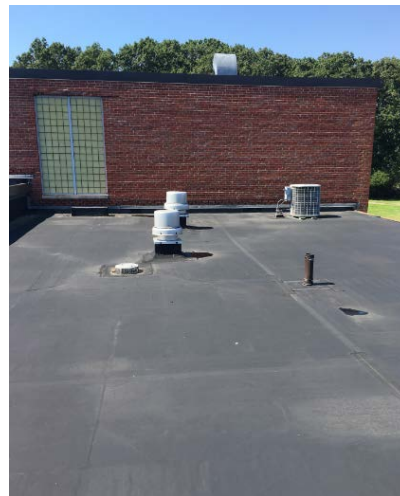
Picture 4: Inoperable EF's, no power

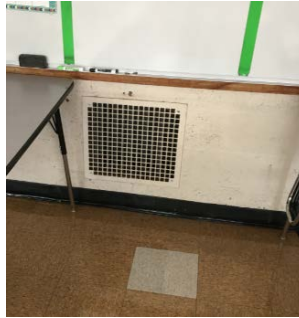
Picture 6: Typical Exhaust

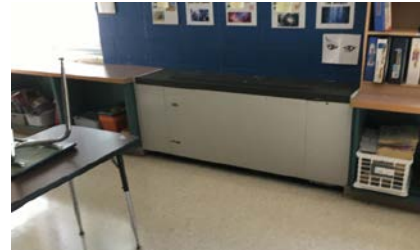
Classrooms served by UV's were found to have a generally acceptable supply and exhaust distribution with UV SA/OA diffuser on the window side of the class, and one exhaust vent on the door side of the room. All of the classrooms inspected had exhaust registers present in them, but not all of the EF's servicing these classrooms were in operation at the time of the inspection.

Picture 7: Typical Classroom UV

All classrooms inspected had a means of supplying OA through the existing UV's. It is recommended to check all UV's at the facility to ensure proper operation, set UV fan speed to high, replace filters as needed and ideally upgrade to MERV 13 if they fit the equipment, set OA minimum damper position to 10%, ensure OA damper responds to commands from BMS, and command OA damper to maximum open position where acceptable space conditions can be maintained during occupied hours. This is defined as maintaining a relative humidity of 40-60% and space temperature of 70-72°F, while providing adequate ventilation per 2015 IMC Standards. Updated Results are shown below in Table 2. **As of the writing of this report, OA dampers on UV's have been commanded to the 50% open position during occupied hours in the new BMS System.**

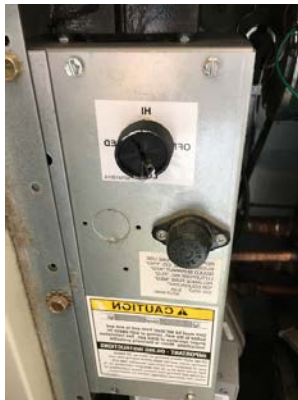
Picture 8: Broken Fan Control Rm 106

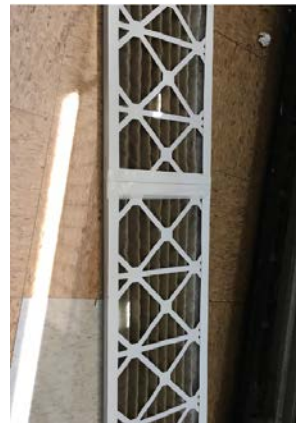
Picture 9: Filter requiring replacement Rm 108

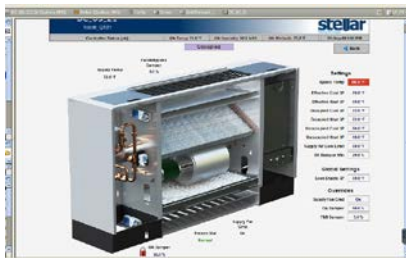
Picture 10: Rm 131 Updated OA Damper Position

At a minimum, OA damper should be between 35-50% open during occupied hours based on the original OA design. Please refer to the original building schedule to determine the exact OA position needed for each UV type. This will also provide an opportunity to make any necessary repairs to each UV at the facility, as it was noted that some UV's had damaged linkages and fan speed control switches. In case the unit was not able to maintain indoor conditions, due to the age of the unit, please refer to the ventilation rates table in the appendix and use the existing post-COVID occupancy rate to calculate the minimum OA flowrate needed. It is also suggested to perform an interior cleaning of each UV while they are open for inspection, maintenance. Of note, 45% of filters inspected were more than 6 months old. Cleaning the inside of the UV cabinets will help prolong UV filter life. At the initial inspection, it was observed that 45% of UV's inspected had OA damper 0% open, the remainder were approximately 10% open.

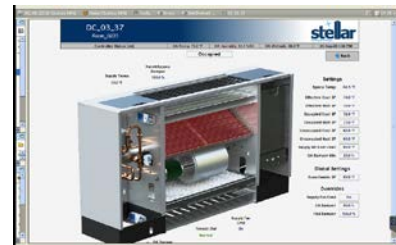
Picture 11: Rm 223 Updated OA Damper Position

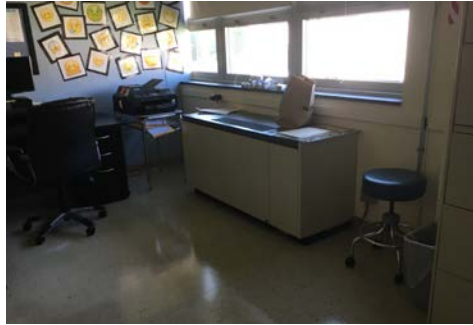
Nurse Room is served by a unit ventilator w/ OA and a dedicated exhaust system. The UV is controlled by a dedicated thermostat. There is a steam radiator present which is not in operation, as well as a mini-split AC unit, and operable windows in the Main Nurse Office. There are supply duct registers present, but these are disconnected from the HVAC system and abandoned in place. The nursing area is broken up into 8 smaller rooms:

Heat and OA is supplied to these rooms by the UV. Each of these rooms has its own exhaust outlet(s), however the EF servicing this area was not in operation at the time of the inspection. This was confirmed visually when inspecting the EF's on the rooftop, the EF located above the Nursing Area was not running. It is recommended to add a means of supplying conditioned outside air directly to the Isolation Room, as this room only has exhaust present.

Picture 10: Nursing Area UV

The Exhaust Fan which serves this area was noted as not being in operation at the time of the inspection. It is imperative to remedy this issue. **As of the writing of this report, it has been noted that this EF has been restored to operation.** The recommended total turnover air rate for the Nurse's area is between 4 to 6 air changes per hour with a minimum of 2 air changes per hour representing fresh outside air. It is also suggested to add a means of supplying conditioned outside air directly to the isolation room to ensure comfort of patients. The nurse room should always operate under negative pressure to eliminate the risk of contaminated air leaving the space.
